**Flood Control Project Maintenance
Levee Inspections**
LMA District Cover Sheet
Spring 2019 Levee Inspection Results

Reclamation District No. 0404 Boggs

Spring 2019 Levee Inspection Results

| Waterway | Bank | Unit Miles |
|---|---|---|
| Unit No. 01 San Joaquin River | Right | 2.35 |

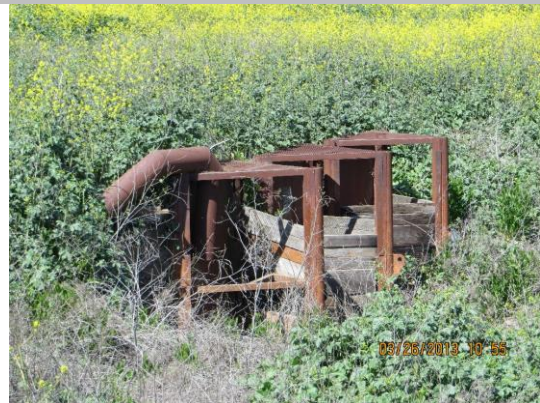
Photo 1 of 3 : UCIP_SP_2019_51168_20041.jpg

| FS_ID:51168 DS_ID:17952 EP_NO: N/A Repair Type: Non-Urgent Crossing Status: Found UCIP Comments: Steel intake structure on landside of the levee. FIELD_STRUCT_DESC: 1 of 3: 30-inch corrugated metal gravity drainage pipe through the levee, 22 feet below the crown. Flap gate on the waterside (WS) end. Steel intake structure on the landside (LS). [Additional Reference(s): DWR Levee Log, 2006]. FS Date: 3/26/2013 | | | | | |

LS- intake structure

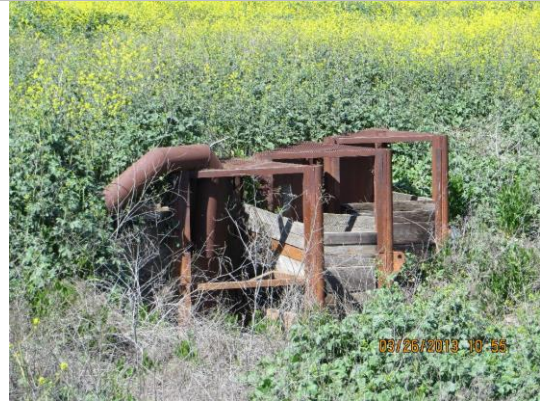
Photo 1 of 3 : UCIP_SP_2019_53348_20047.jpg

| FS_ID:53348 DS_ID:18811 EP_NO: N/A Repair Type: Non-Urgent Crossing Status: Found UCIP Comments: 10/2/2018 The wide levee crown shows no sign of integrity issues; downgrading to Non-Urgent (D. Sanoski - DWR UCIP).12/13/2016 Since previous inspector and 2006 Levee Log cite damage to flap gate, I have upgraded this crossing from Non-Urgent to Urgent. Flap gates need to be in good working condition. (K. Fazel - UCIP)03/26/2013 Steel intake structure on LS. (P. Amatya - DWR)12/26/2006 Landward end filled with dirt. Middle flap gate missing and right flap gate broken as of 1/24/07. (DWR Levee Log) FIELD_STRUCT_DESC: 2 of 3: 30-inch corrugated metal gravity drainage pipe through the levee, 22 feet below the crown. Flap gate on the waterside (WS) end. Steel intake structure on the landside (LS). [Additional Reference(s): DWR Levee Log, 2006]. FS Date: 10/2/2018 12:51:00 PM | | | | | |

LS- steel intake structure

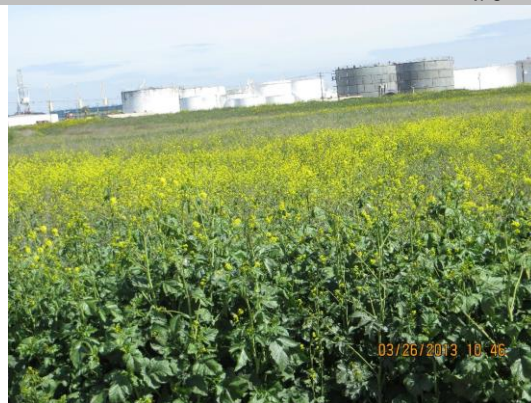
Photo 3 of 3 : UCIP_SP_2019_53348_20048.jpg

LS- overview of landside of the levee

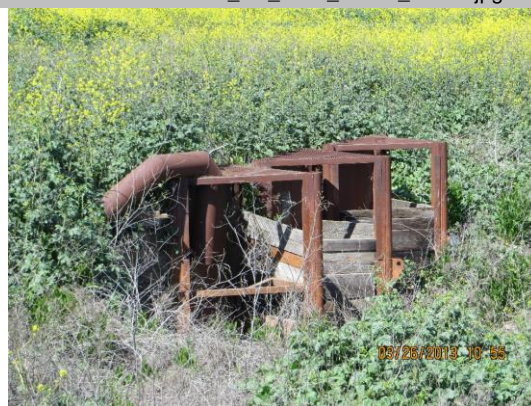
Photo 1 of 3 : UCIP_SP_2019_53349_20054.jpg

| FS_ID:53349 DS_ID:18810 EP_NO: N/A Repair Type: Non-Urgent Crossing Status: Found UCIP Comments: 10/2/2018 The wide levee crown shows no sign of integrity issues; downgrading to Non-Urgent (D. Sanoski - DWR UCIP).12/13/2016 Since previous inspector and 2006 Levee Log cite damage to flap gate, I have upgraded this crossing from Non-Urgent to Urgent. Flap gates need to be in good working condition. (K. Fazel - UCIP)03/26/2013 Steel intake structure on LS. (P. Amatya - DWR)12/26/2006 Landward end filled with dirt. Middle flap gate missing and right flap gate broken as of 1/24/07. (DWR Levee Log) FIELD_STRUCT_DESC: 3 of 3: 30-inch corrugated metal gravity drainage pipe through the levee, 22 feet below the crown. Flap gate on the waterside (WS) end. Steel intake structure on the landside (LS). [Additional Reference(s): DWR Levee Log, 2006]. FS Date: 10/2/2018 12:33:00 PM | | | | | |

LS- steel intake structure

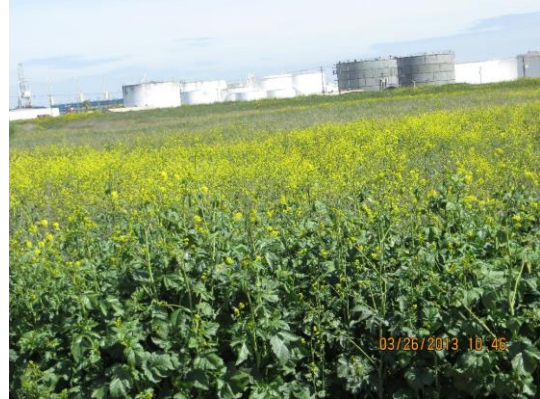
Photo 3 of 3 : UCIP_SP_2019_53349_20052.jpg

LS- overview of landside of the levee.

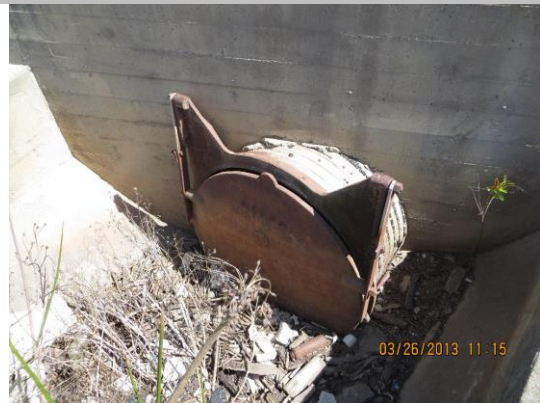
Photo 2 of 3 : UCIP_SP_2019_53532_19962.jpg

FS_ID:53532
DS_ID:17945
EP_NO: N/A
Repair Type: No Action Needed
Crossing Status: Found
UCIP Comments: 11/22/2017 Received updated photo from DWR levee inspector D. Torres showing gate has been cleared of sediment to allow operation of the gate on the WS. Crossing has been downgraded from Urgent to No Action Needed based on the 2016 photos and the most current photo. Recommend coordinating with City of Stockton to determine as-builts, CVFPB permit, and date of last internal integrity inspection completed for this crossing. (DWR UCIP - O. Magana)

WS- drainage outlet structure and CM pipe with flapgate

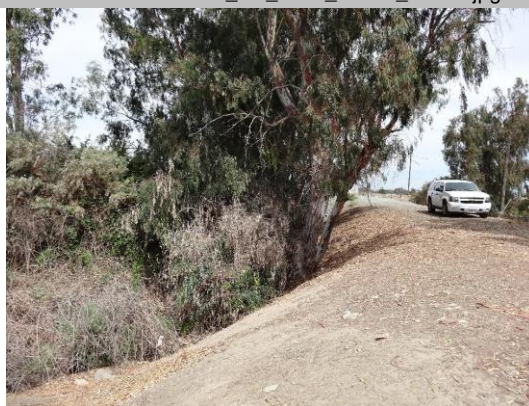
Photo 3 of 3 : UCIP_SP_2019_46810_74755.jpg

WS view at crossing looking north

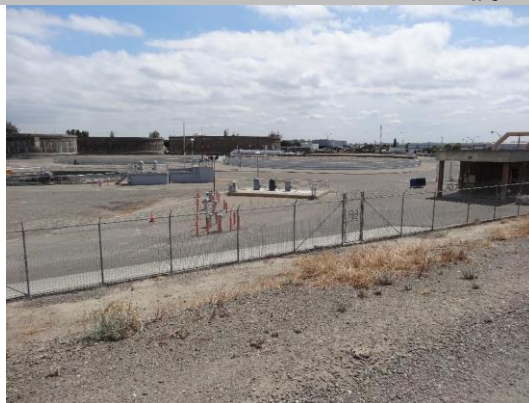
Photo 1 of 3 : UCIP_SP_2019_46801_74745.jpg

| FS_ID:46801 DS_ID:25128 EP_NO: 1164 Repair Type: Non-Urgent Crossing Status: Indicator Found UCIP Comments: Conversation with WWTP engineer Ali Gharegozloo suggested this pipe has been welded shut. If so, mode of abandonment needs verification. FIELD_STRUCT_DESC: 60-inch lock joint reinforced concrete sewage effluent pipe under the levee, 27 feet below the crown. Reinforced concrete apron and cutoff walls. Steel sheet piling apron installed with the pipe on the waterside (WS) slope. Headwall, stairs, and pump with shutoff valve visible on the WS slope. Apparent shutoff valves 30 feet off the landside (LS) toe in alignment with the pipe. (Plans for the construction of a 60-inch lock joint reinforced concrete sewage effluent pipe under the easterly levee of the San Joaquin River authorized under Permit No. 1164, 1947 - City of Stockton). FS Date: 7/9/2015 | | | | | |

LS view: apparent shut off valves on WWTP property in alignment with 60-inch pipe.

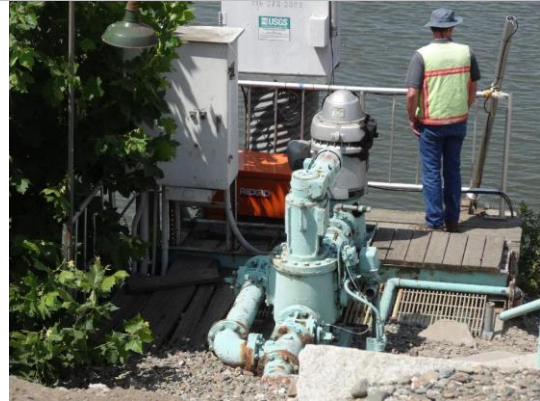
Photo 3 of 3 : UCIP_SP_2019_46801_74748.jpg

WS view: closeup of pump. CMP riser for USGS gage behind pump.

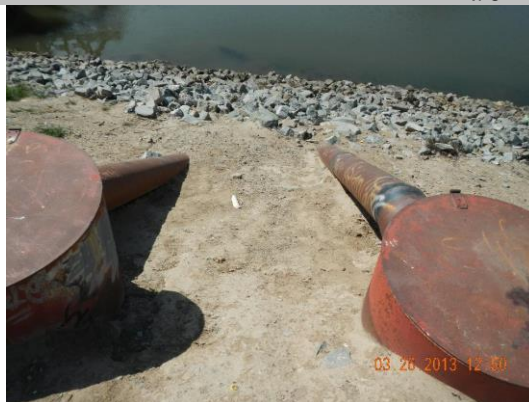
Photo 2 of 3 : UCIP_SP_2019_50763_20103.jpg

WS- steel pipes and siphon breakers in steel pipe risers.

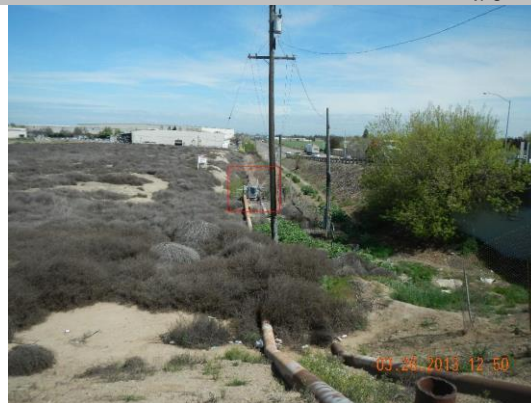
Photo 3 of 3 : UCIP_SP_2019_50763_20102.jpg

LS- pipes and pumps (center)

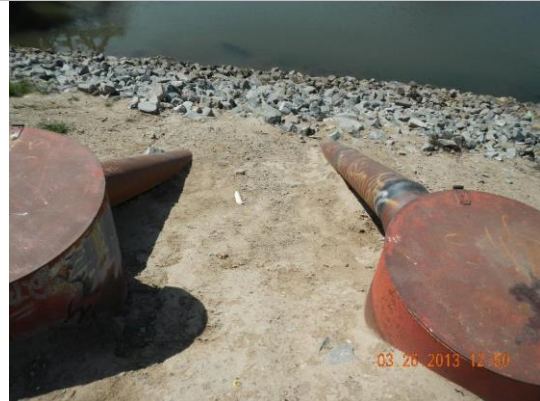
Photo 1 of 3 : UCIP_SP_2019_50764_19994.jpg

| FS_ID:50764 DS_ID:17955 EP_NO: 4175 Repair Type: Non-Urgent Crossing Status: Found UCIP Comments: 11/17/2016 FPIIB Inspector Richard Willoughby noted 3-4 inch dip in crown over pipes, an indication of possible pipe collapse. (K. Fazel - UCIP) FIELD_STRUCT_DESC: 2 of 2: 12-inch steel drainage discharge pipe through the levee, 5 feet below the crown. Siphon breaker on the waterside (WS) shoulder. Power pole, electrical control panel, and pump about 200 feet off the landside (LS) toe. (Plans for installation of a 10-inch, 12-gauge welded steel discharge pipe over the levee authorized under Permit No. 4175, 1963 - City of Stockton). [Additional Reference(s): DWR Levee Log, 2006, 10-inch pipe referenced]. FS Date: 11/17/2016 | | | | | |

WS- steel pipes and siphon breakers in steel pipe risers.

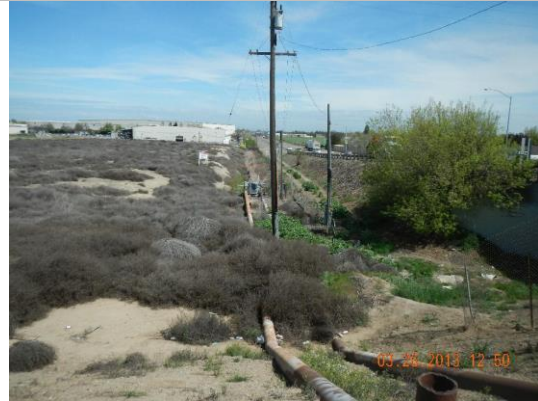
Photo 3 of 3 : UCIP_SP_2019_50764_19995.jpg

LS- pipes and pumps on center.

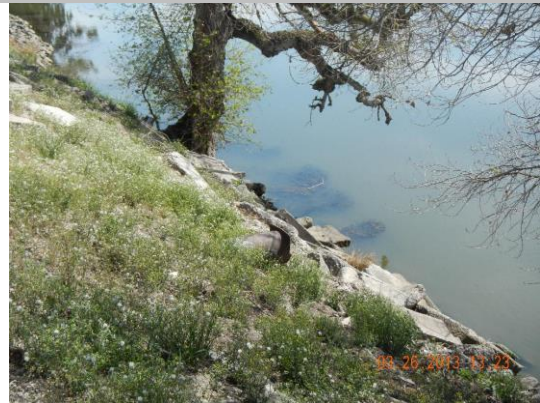
Photo 1 of 3 : UCIP_SP_2019_40487_20064.jpg

| FS_ID:40487 DS_ID:18812 EP_NO: 10897 Repair Type: Non-Urgent Crossing Status: Found UCIP Comments: Abandoned crossing. WS pipe capped with steel pipe and LS pipe cut. FIELD_STRUCT_DESC: *ABANDONED* 14-inch irrigation discharge pipe of an unknown material through the levee, 3 feet below the crown. Siphon breaker on the waterside (WS). (Plans to install a 20-horsepower irrigation pump on an existing structure and a 14-inch discharge pipe through the levee authorized under Permit No. 10897, 1975 - Alfred Volpi. 14-inch pipe replaces existing 12-inch pipe). [Additional Reference(s): DWR Levee Log, 2006. USACE San Joaquin O&M Manual 1, March 1963, (HLM 1.63), 12-inch pipe referenced, 5.5 feet below the crown]. FS Date: 3/26/2013 | | | | | | |

WS- steel pipe capped with steel plate.

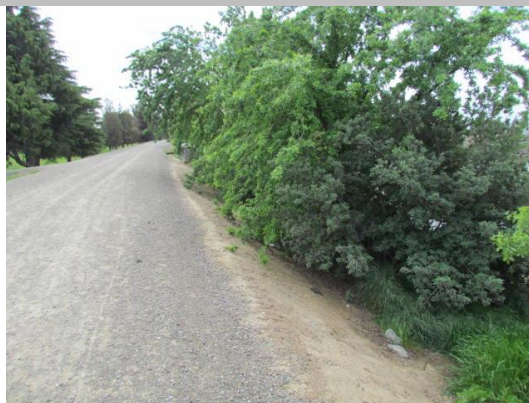
Photo 2 of 2 : SP_2019_RD0404_305_29_20190313_00015.jpg

Looking south at dense vegetation on waterward slope.

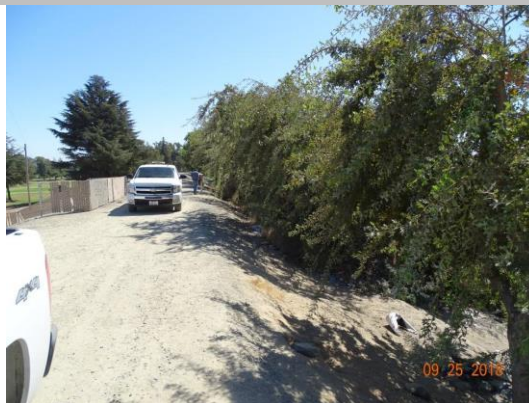
Photo 1 of 2 : SP_2019_RD0404_305_23_20190313_00011.jpg

| Site is not being maintained and is overgrown. | | | | | |

Looking southwest at overgrown site on waterward slope. (Fall 2018)

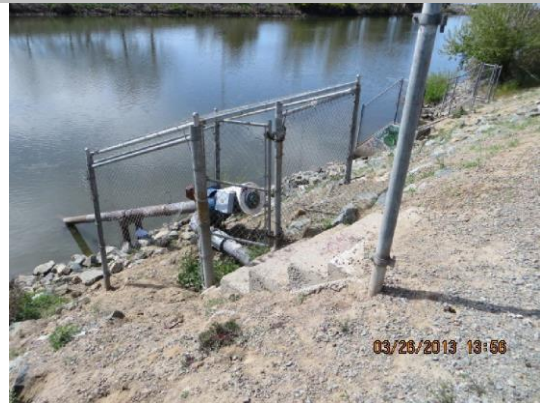
Photo 1 of 3 : UCIP_SP_2019_40797_20073.jpg

| FS_ID:40797 DS_ID:17961 EP_NO: 6560 Repair Type: Non-Urgent Crossing Status: Found UCIP Comments: Damaged siphon breaker in pipe riser near the landward shoulder. FIELD_STRUCT_DESC: 8-inch steel irrigation discharge pipe through the levee, 7 feet below the crown. Chain-link fence around the pump and motor on the waterside (WS) slope. (Plans to install a 7-horsepower pump and motor, cyclone fence, and an 8-inch steel pipe through the levee authorized under Permit No. 6560, 1969 - City of Stockton, Department of Public Works). [Additional Reference(s): DWR Levee Log, 2006]. FS Date: 3/26/2013 | | | | | |

WS- slanted pump, pipe, and concrete steps on levee slope.

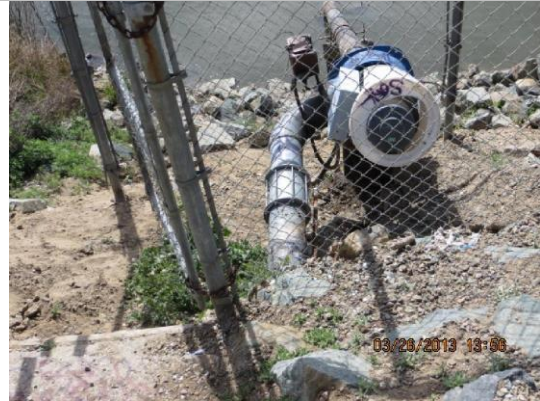
Photo 2 of 3 : UCIP_SP_2019_40797_20072.jpg

WS- slanted pump, and pipe on levee slope.

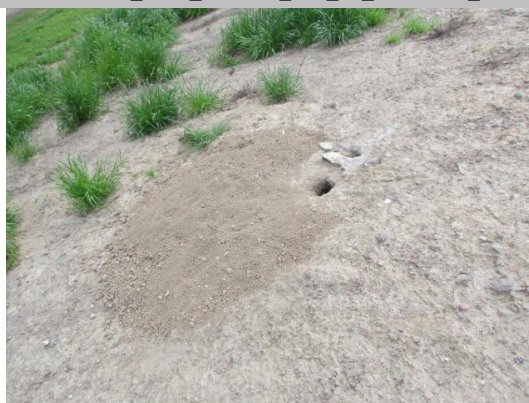
Photo 1 of 2 : SP_2019_RD0404_306_21_20190313_00009.jpg

Looking northeast at large rodent hole on landward slope.

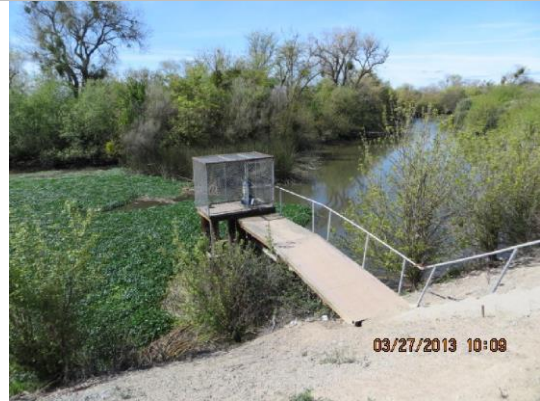
Photo 1 of 3 : UCIP_SP_2019_10908_18182.jpg

WS- pump on steel structure and wooden walkway

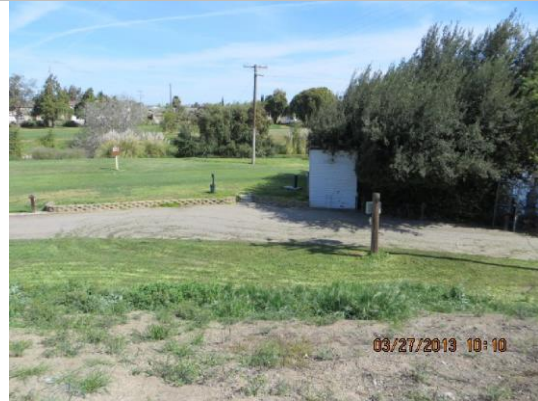
Photo 3 of 3 : UCIP_SP_2019_10908_18180.jpg

| FS_ID:10908 DS_ID:18781 EP_NO: 3340A Repair Type: Non-Urgent Crossing Status: Found UCIP Comments: - Not working for 5 years- Golf club staff- Wooden Walkway; Concrete steps- Damaged siphon breaker FIELD_STRUCT_DESC: 6-inch steel irrigation discharge pipe through the levee, 2 feet below the crown. One corrugated metal cutoff wall. Pump on a pile structure in the stream. Shutoff valve and siphon breaker on the waterside (WS) shoulder. Timber walkway on the WS slope. (Plans for installation of three pumping plants on the north levee of French Camp Slough authorized under Permit No. 3340-A, 1960 - City of Stockton). [Additional Reference(s): DWR Levee Log, 2006]. FS Date: 3/27/2013 | | | | | | |

LS- overview of LS slope

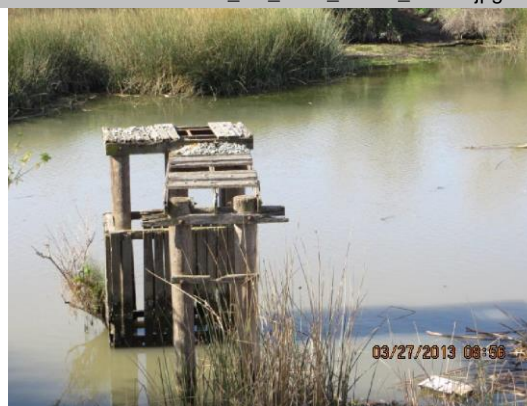
Photo 3 of 3 : UCIP_SP_2019_51171_18132.jpg

| FS_ID:51171 DS_ID:18792 EP_NO: 3340 Repair Type: Non-Urgent Crossing Status: Indicator Found UCIP Comments: 11/29/2016 Pipe was not found. As per DWR Inspector Richard Willoughby, pipe was removed by City without a permit. Erosion cited previously has been backfilled. Backfill material on WS is redder in color than original material, indicating a recent backfill. Crossing has been downgraded from Urgent to Non-Urgent since no permit issued for this work. (K. Fazel - UCIP)03/27/2013 Abandoned and capped 3-in GI pipe found on WS. Damaged air-valve/siphon breaker found on LS. Gully formed due to leaky pipe. A pump house found on LS but it needs to be verified by LMA whether this is associated with this crossing. (P. Amatya - DWR) FIELD_STRUCT_DESC: *REMOVED* 3-inch galvanized iron irrigation discharge pipe through the levee, 1 foot below the crown. Pile structure in the stream. Damaged siphon breaker at the landside (LS) toe. (Plans for installation of three pumping plants on the north levee of French Camp Slough authorized under Permit No. 3340-A, 1960 - City of Stockton). FS Date: 11/29/2016 | | | | | | |

WS- abandoned pump station.

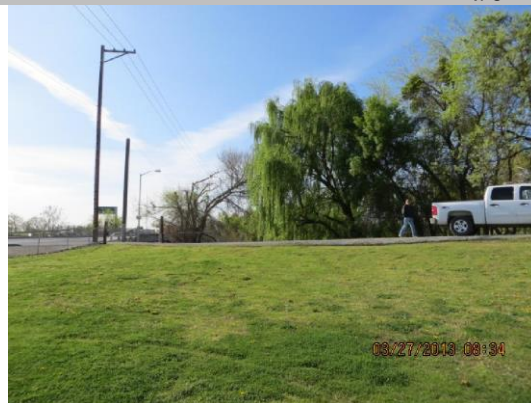
Photo 2 of 3 : UCIP_SP_2019_10846_18126.jpg

Crown view of the levee.

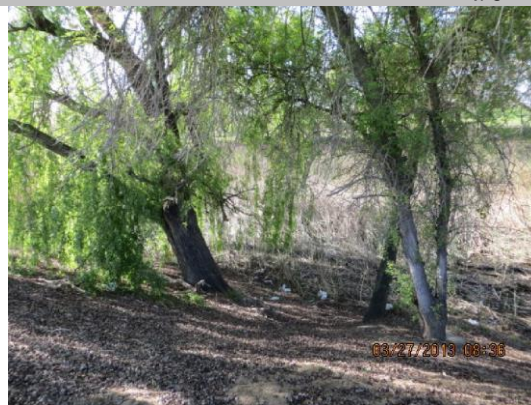
Photo 3 of 3 : UCIP_SP_2019_10846_18128.jpg

WS- no pipes found.

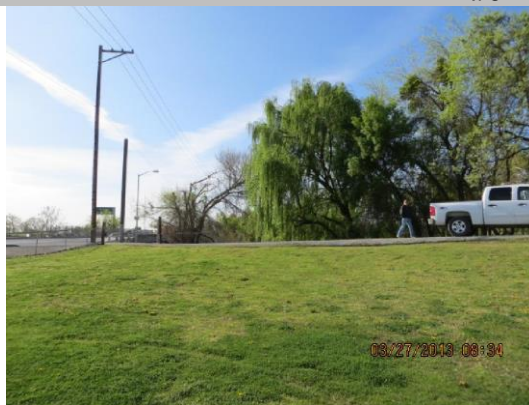
Photo 2 of 3 : UCIP_SP_2019_12426_20129.jpg

Crown view of the levee.
